COUNTRY	Czechoslovakia	REPORT NO.		50X1
SUBJECT	Location of Alleged Radar Towers	DATE DISTR.	5 October 1955	
		NO. OF PAGES	6	
DATE OF INFO.		REQUIREMENT NO.		50X1
PLACE ACQUIRED		REFERENCES		50X1
DATE ACQUIRED

**SUBJECT** Location of Alleged Radar Towers

Reference is made to page 3, overlay on GSQS 4416, sheet V-8, 1:100,000, Vodnany, on which source identified the following points:

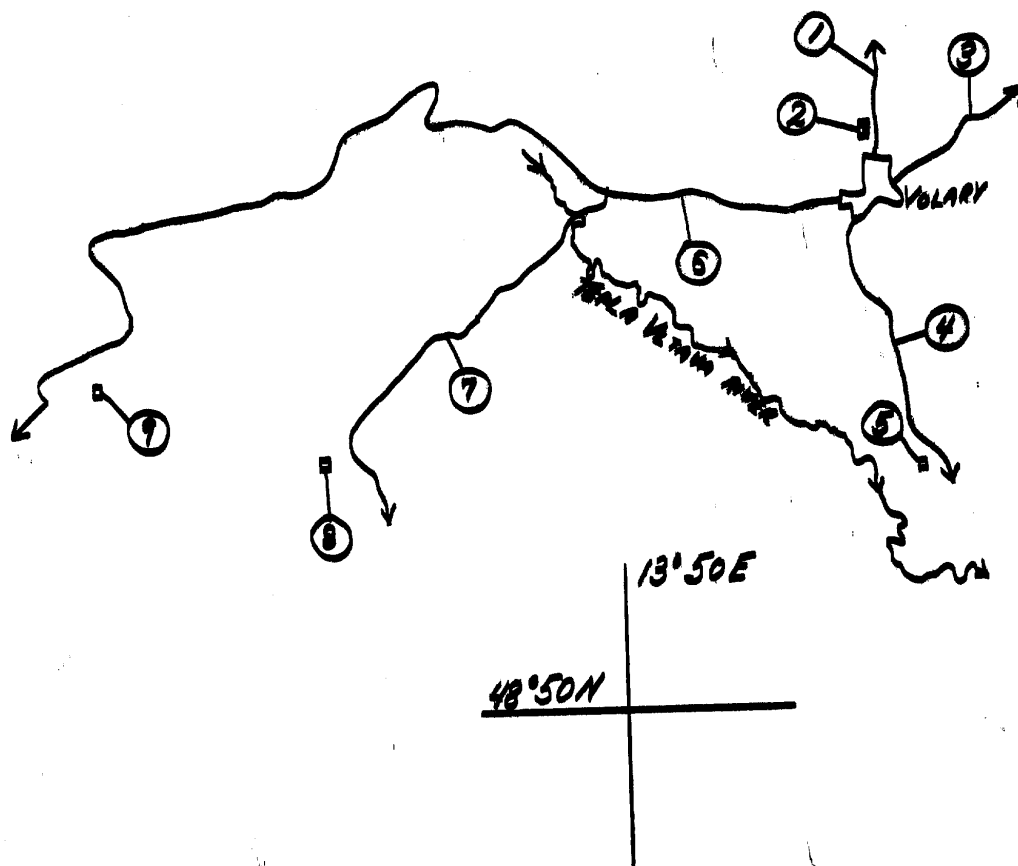
Overlay on GSGS 4416  
Sheet V-8  
Scale 1:100,000  
Vodnany

1. Road to Mlynarovice (N 48-58, E 13-54), gravel, five meters wide, no traffic.
2. Villa located in a garden. Three-story brick construction, 25 x 25 m. This villa was located about 50 m. north of the last house of Volary (N 48-55, E 13-53) and about 300 m. west of the road to Mlynarovice, point 1. The villa was constructed in 1951 - 1952. There was a wooden fence about 1.5 m. high around the villa. The villa was guarded at all times by a military guard with a dog. This villa housed the command post of the radar towers in this area, which had an infantry lieutenant in charge. There were 17 enlisted men physically present at the villa at all times. Nine of the men were replacements for the men at the alleged radar towers, points 5, 8 and 9, three men for each tower. The other eight men worked at the villa, four at one time. They were on duty for 24 hours and then had 24 hours off. The entire command consisted of one officer (lieutenant) and 26 EM. The ranks of all the men were corporal and higher. Source did not observe any radar equipment or antennas in the area. He believed all equipment to be located in the 3 x 3 m. wooden barrack built over a dugout, where the men on duty worked. This barrack was located in the garden. No vehicles of any kind were assigned to this command. Source's belief that this was the radar tower

5. Alleged radar tower, located 20 m. west of the highway, point 3. There were three men on duty at this tower. Two of them were working inside the tower. The third man was outside the tower with a dog, performing guard duties. These men were replaced every 24 hours by three men from the command post, point 2. The telephone in the tower was connected to the main telephone line running alongside the highway, point 3. Source did not know if the area around the tower was restricted. He stated that the tower was surrounded by fields, and that farmers working the field probably could get close to the tower. Source was never inside the tower, and did not observe any radar equipment or antennas. For dimensions and view of the tower see page 5, this report. 50X1

7. Road to Ceske Zleby (N 48-53, E 13-48), gravel, five meters wide, bad condition, no traffic except military.
8. Alleged radar tower, located about 200 m. west of the highway, point 9, and about 300 m. southwest of the center of Ceske Zleby. Telephone connected to the main telephone line running alongside the road, point 7. For further information see point 5 above.

9. Alleged radar tower, located 400 m. east of the highway, point 6. Telephone connected to the main telephone line running alongside highway; point 6. For further information see point 5 above.

3. Highway to Prachatice (N 49-01, E 14-00), asphalt, six meters wide, very good condition, heavy traffic. This highway was reconstructed in 1955.
4. Highway to Horni Plana (N 48-46, E 14-02), asphalt, six meters wide, very good condition, heavy traffic. Reconstructed  50X1

6. Highway to the Czechoslovak-German border, asphalt, seven meters wide, good construction, reconstructed  light traffic. This highway was not utilized as one of the regular border-crossing points. It was closed at the Czechoslovak border by a 2.5 m. wide and 2.5 m. deep ditch. 50X1

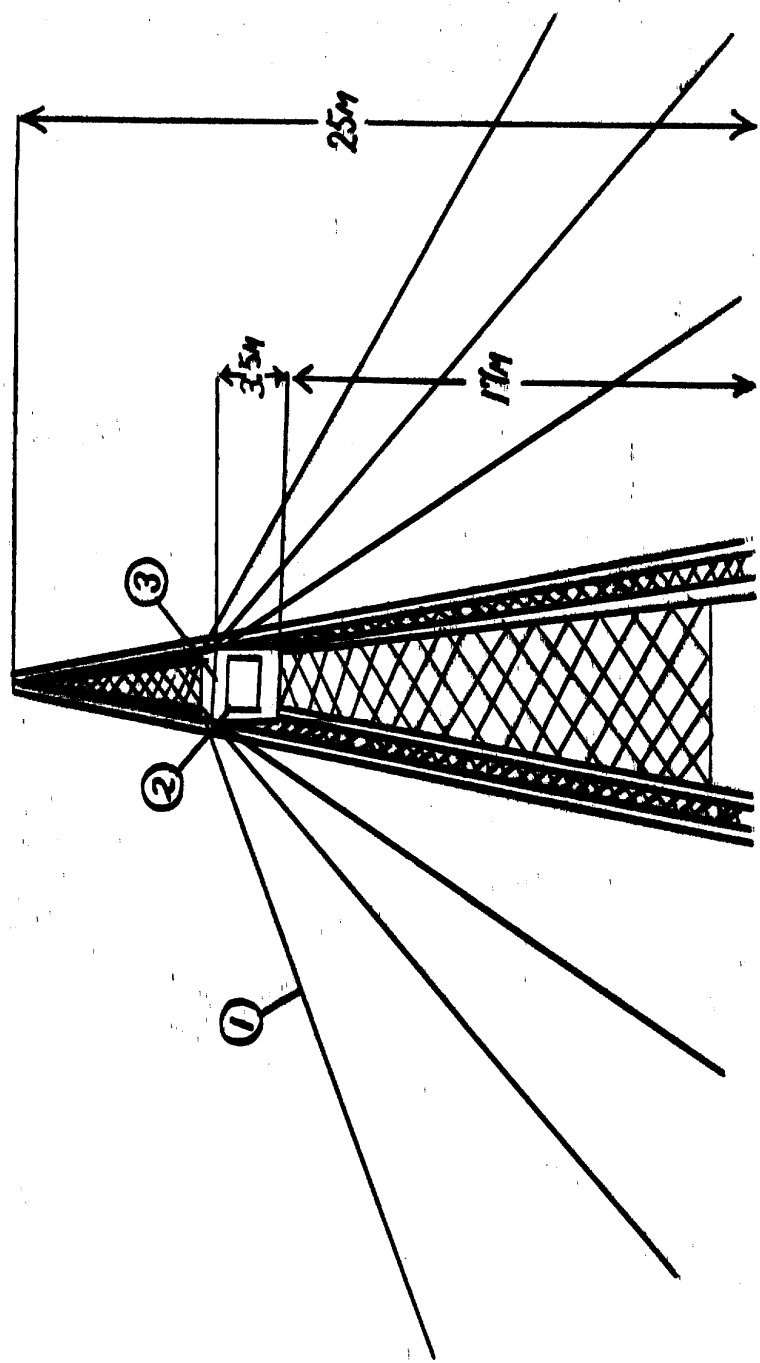
Memory Sketch of Alleged Radar Tower

Reference is made to page 5,  sketch of the alleged radar tower:

1. A cable, five millimeters thick and 25 m. long, used for steadying the tower. There were seven or eight such cables at each tower.
2. Glass window, 2 x 2 m. There was one window on each of the four sides of the booth. Source stated that it was possible that there was one in the roof of the booth also.
3. Alleged radar booth, wood construction, 4 x 4 x 3.5 m., located 17 m. above ground. This booth was supported by four wooden pillars, one on each corner. Cross bars were nailed to the pillars along the entire length of the tower on all four sides. The entrance to the booth was by a ladder through a trap door in the bottom of the booth. All equipment was located in this booth; two men worked inside.
